## Report 2017

Görün Arun, President of ISCARSAH

In 2017, we made two meetings; in Seoul, Korea on June 6<sup>th</sup>, 2017 and in Delhi, India on December 9<sup>th</sup>, 2017 during ICOMOS General Assembly.

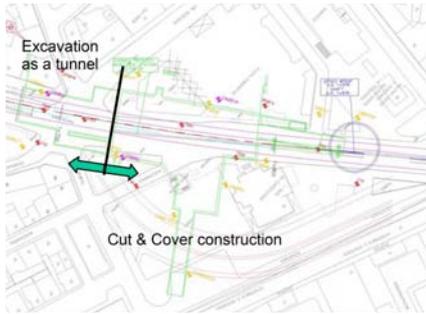
Fig. 4. Ground plan of Athens Metro Peristeri Station.

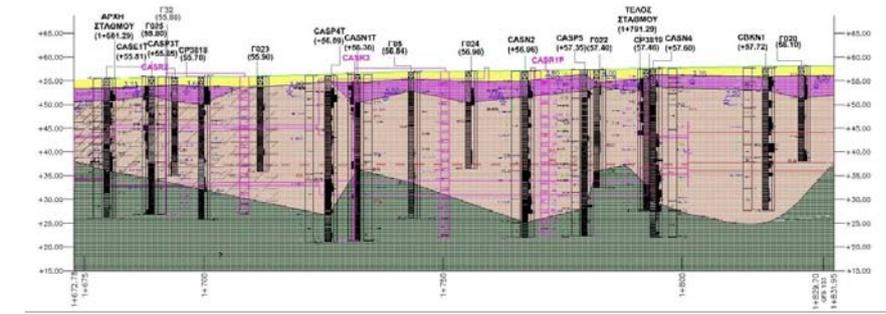
Fig. 5. Geological section along the Peristeri Station (Yellow: surface deposits, Magenta: conglomerate - breccia, Pink: Athenian Schist - Sandstone phase, Deep Green: Athenian Schist - Siltstone phase).

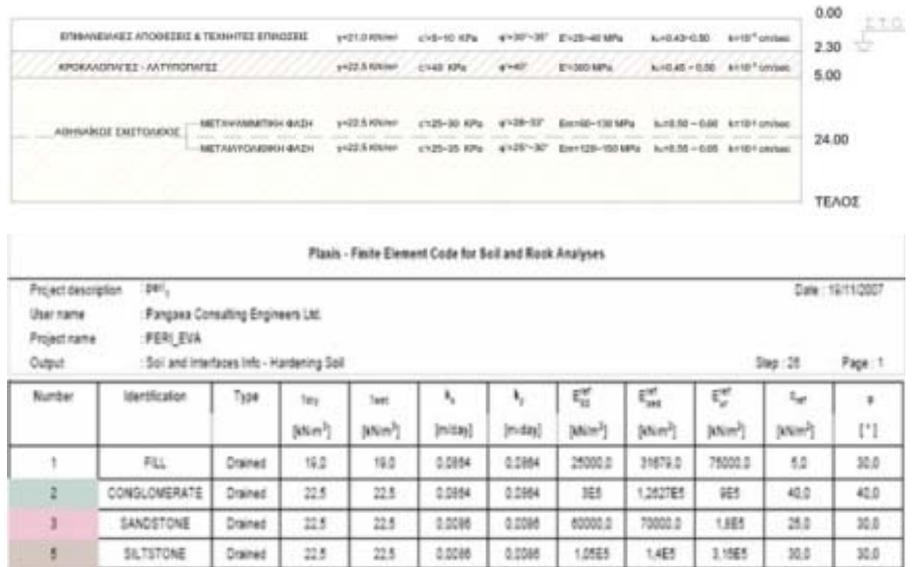
Fig. 6. Geotechnical section along the Athens Metro Peristeri Station.

It has been found that in rock masses like the Athenian Schist, a flysch formation, depending on the assumption on the values of  $E_i$  or  $\sigma_{ci}$  to be used, the rock mass deformation modulus could extremely vary. Hence, the estimated deformations of the structure to be constructed or the retained neighbouring structures may vary considerably. The Athenian Schist in this specific

location appears as a rock mass of very poor to medium quality (GSI ranges from 10 to 60), while there are locations where it is completely altered ("soily"). The question that arises is what is considered as intact rock in such case and how can we measure the  $E_i$  or  $\sigma_{ci}$  of this intact rock. It was suggested that when dealing with heavily weathered and/or heavily fragmented rock masses the MR or  $\sigma_{ci}$  should be taken from the literature. Applying values of  $\sigma_{ci}$  and MR from the literature led to big discrepancies between these estimations of the rock mass deformation modulus and the pressure meter's measurements. On the contrary, when average  $\sigma_{ci}$  values from uniaxial compression tests on weathered-altered rock specimens were used, the estimations of the rock mass deformation modulus were in very good agreement with the pressure meter's measurements. The response of the structures to the excavation supports the later finding; hence the assumption on

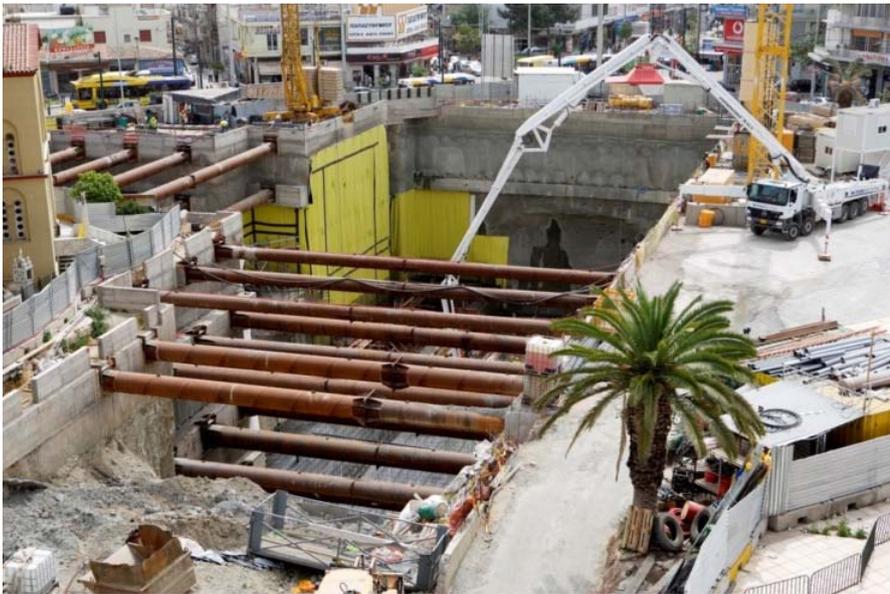
Fig. 7. General view of the excavation of the *Peristeri* Station.

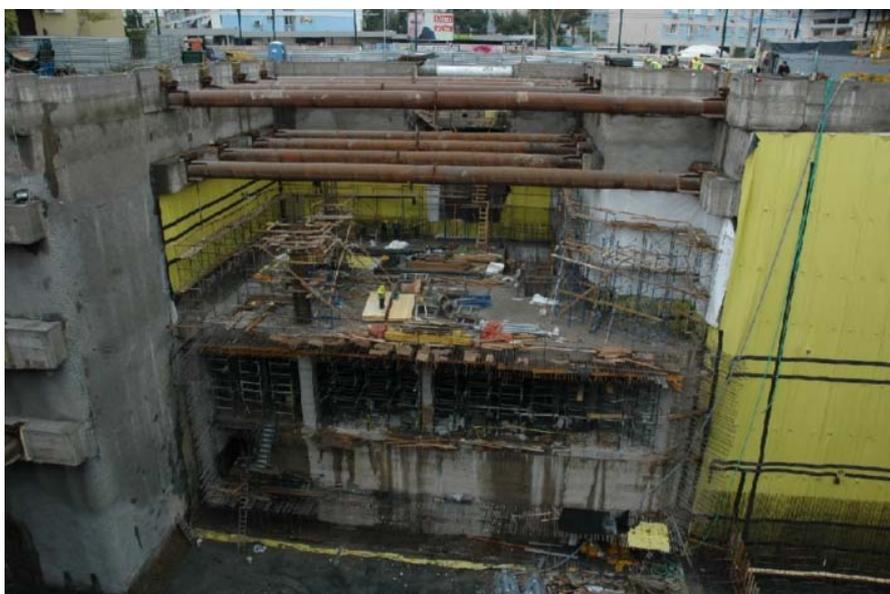
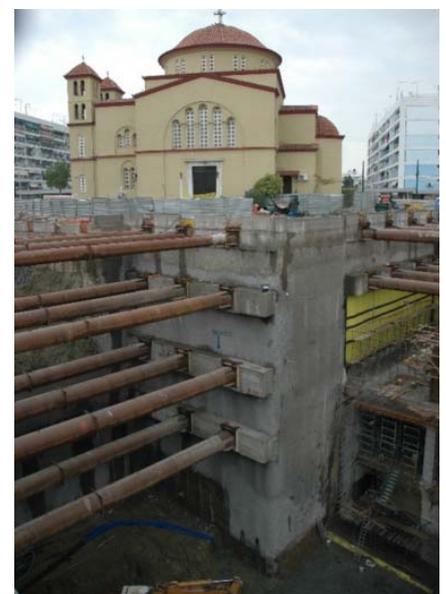
Fig. 8. The excavation support system of the *Peristeri* Station next to the Evaggelistria Church.

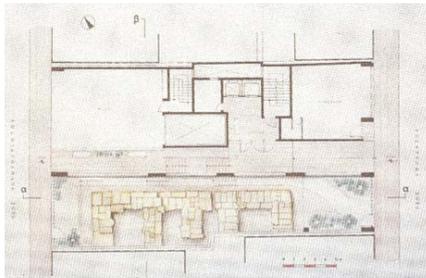
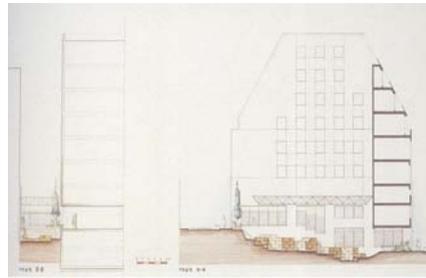
Figs. 9 and 10. Ground-plan and sections of the office building and the Filon's warehouse antiquities.

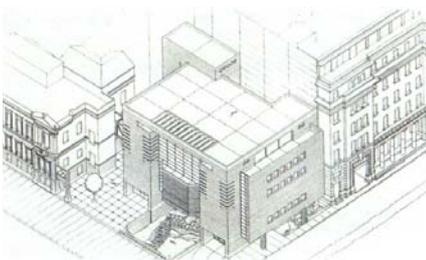
Fig. 12. Drawing of the National Bank of Greece Administration Building with the antiquities preserved in the ground floor – basement.

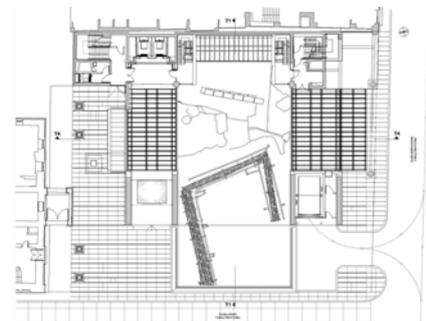
Fig. 13. Ground – basement plan of of the National Bank of Greece Administration Building.

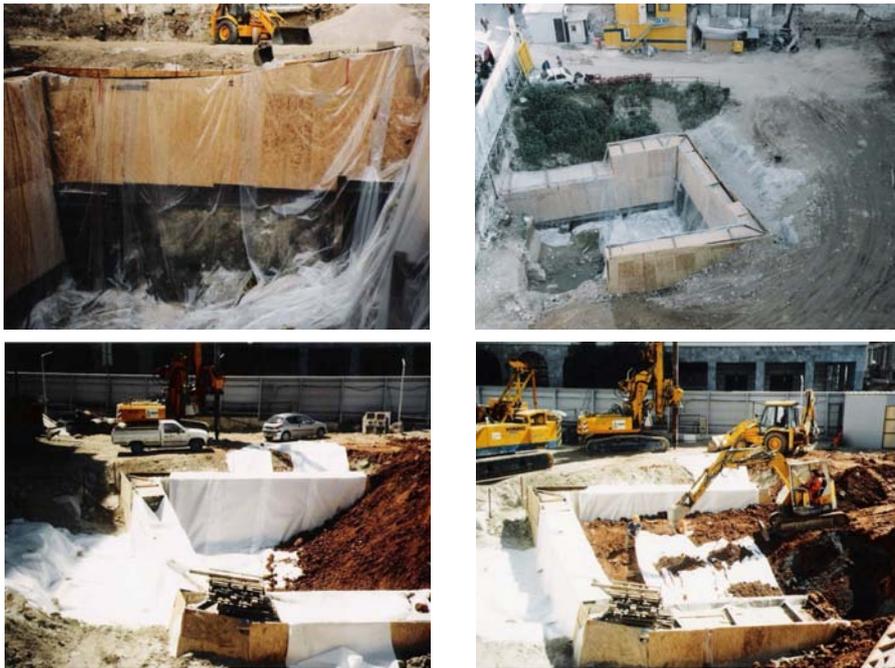
Fig. 16. Protection of the antiquities before earth filling.

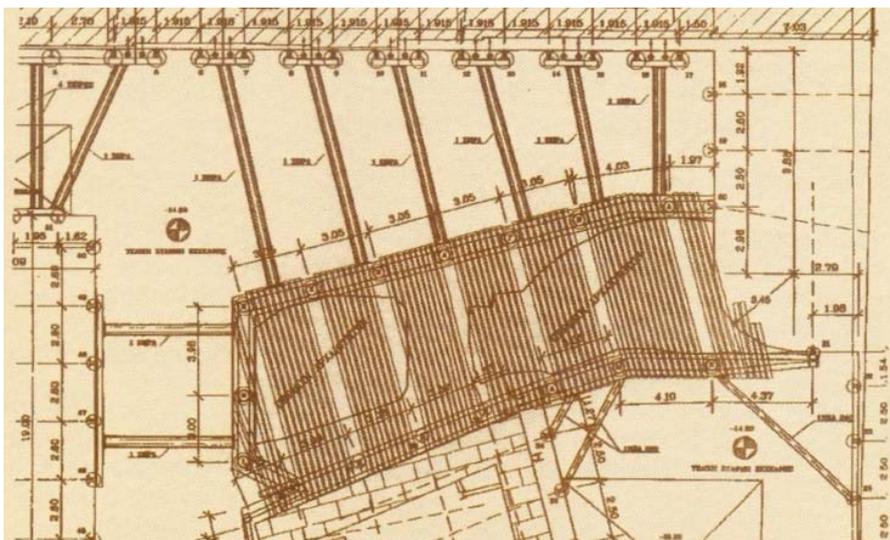
Fig. 17. Plan of the temporary support system for the construction of the National Bank of Greece Administration Building.

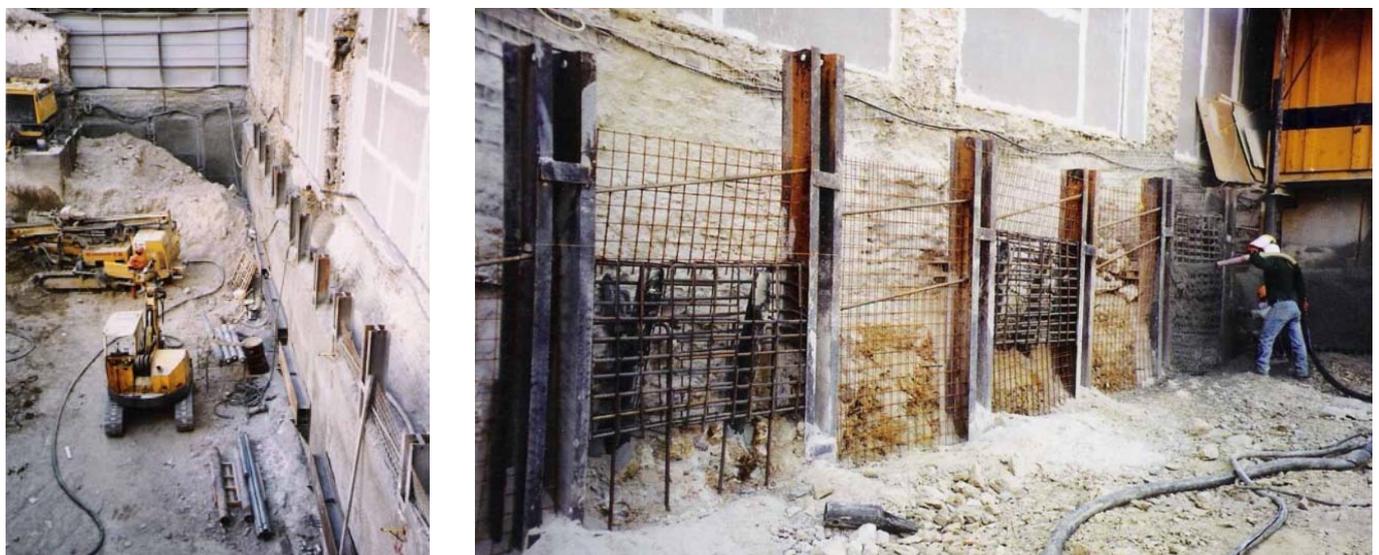
Fig. 18. The "Berlin" type of wall used for the temporary support of the excavation slopes.

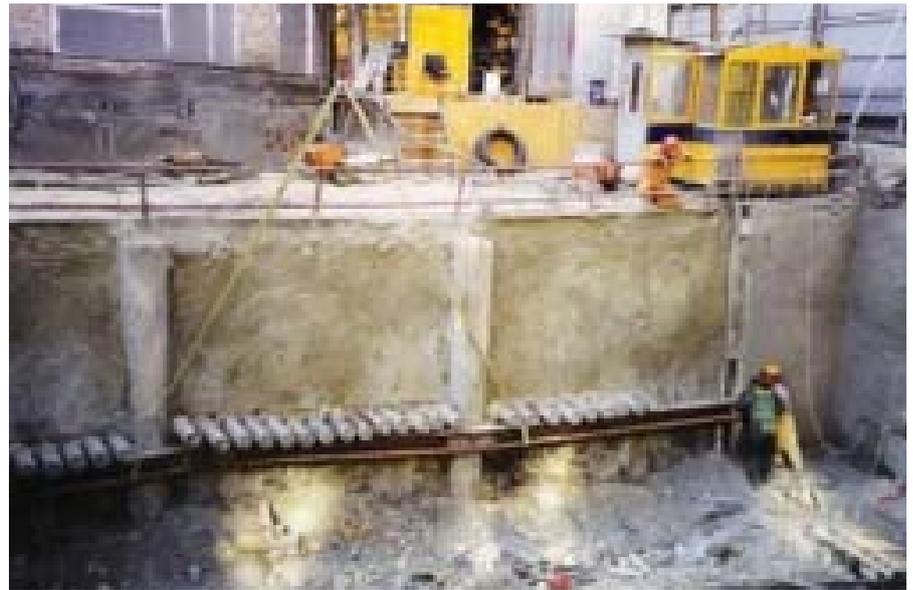
Fig. 19. Construction of the fore poles under the antiquities.

In the next stage the forepoles were constructed using  $\varnothing 250 \text{ mm}$  rotary hammer drill and reinforcement consisting of two concentric steel tubes, the external having external diameter  $\varnothing 193.7 \text{ mm}$  and thickness 7.1 mm and the internal having external diameter  $\varnothing 139.7 \text{ mm}$  and thickness 7.1 mm.

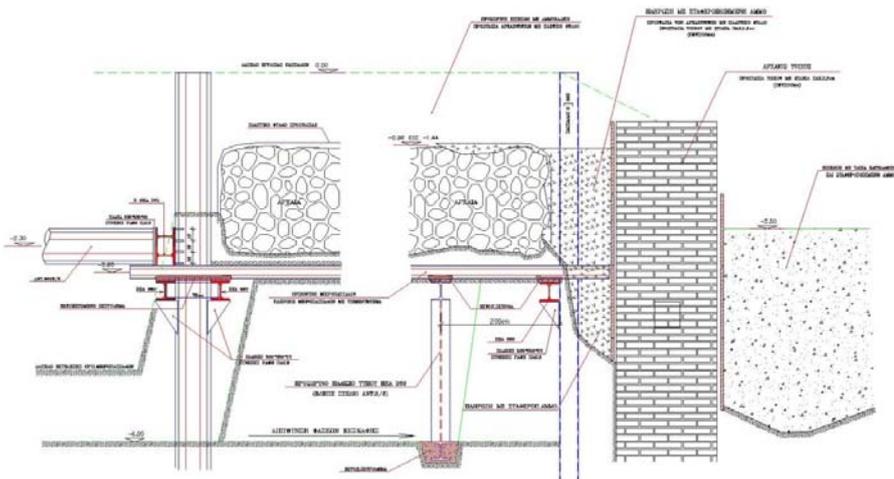
Fig. 20. shows details of the support of the antiquities.

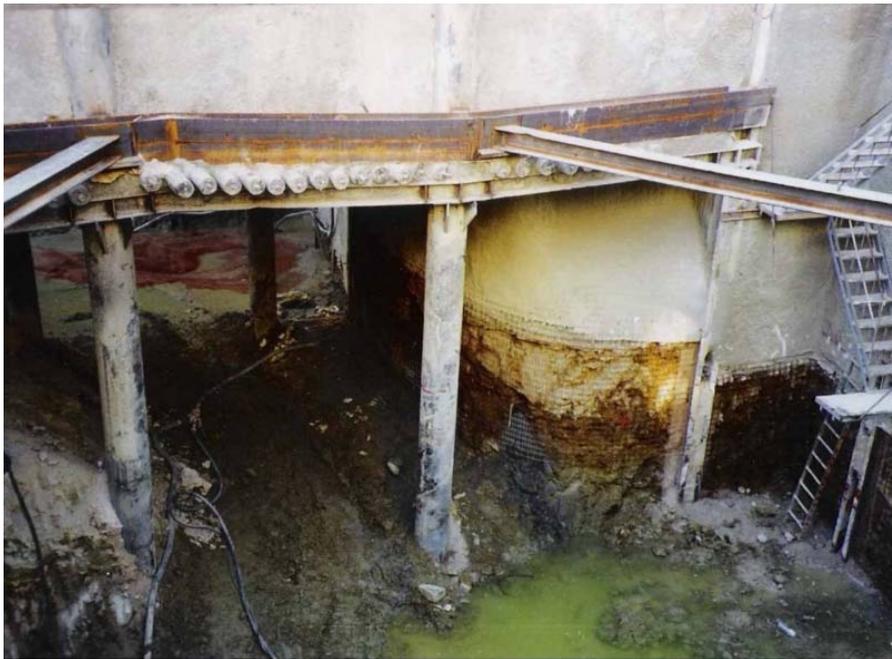
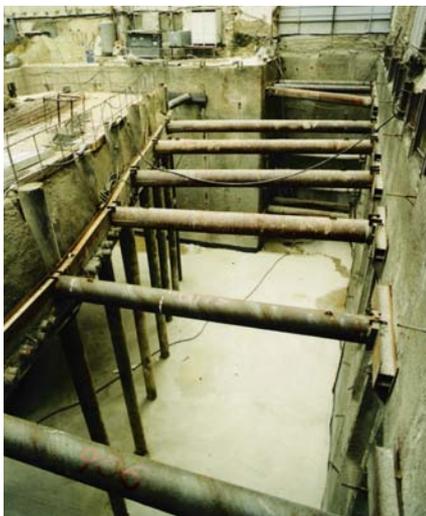
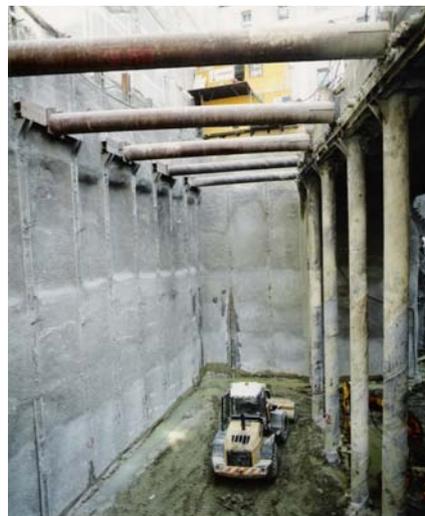
Fig. 22. Partial excavation (a) and excavation to the final level (b, c).

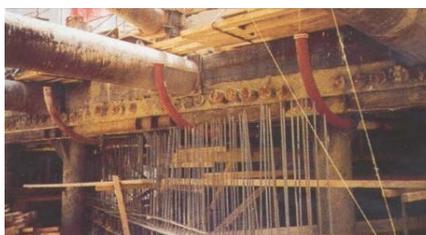
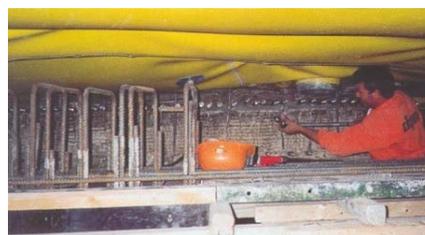
Figs. 23 and 24. Details of the preparations for concreting the slabs under the antiquities.

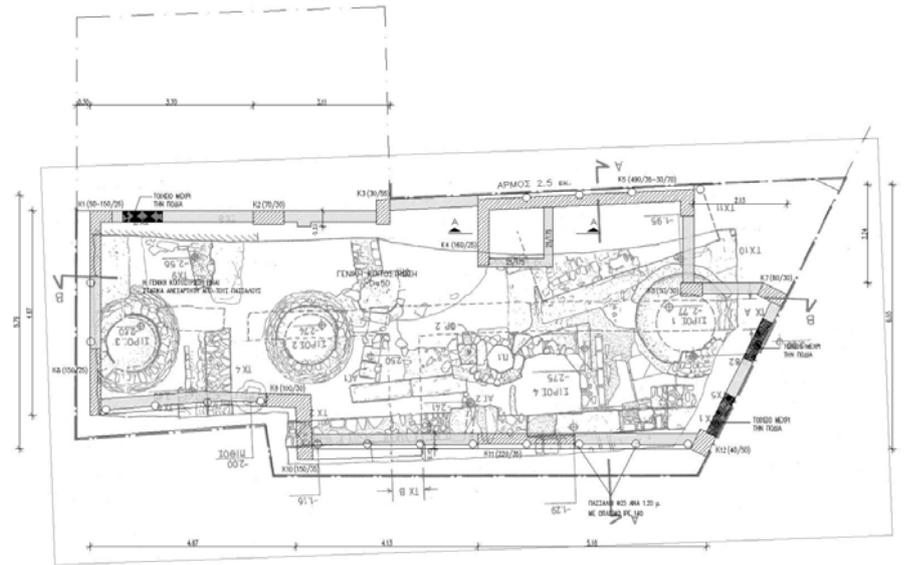
Fig. 27. Plan of the foundation of the building at Cherefontos with the antiquities found.

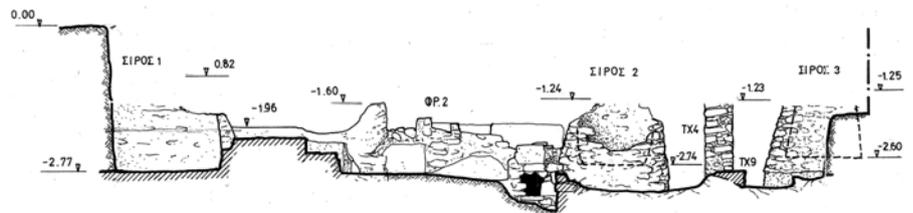
Fig. 28. Section along the Cherefontos site with the antiquities found.

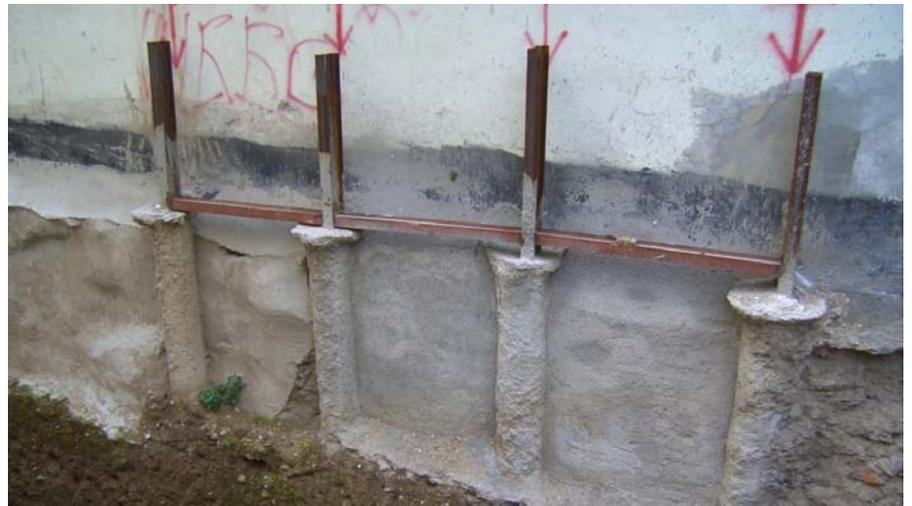
Fig. 29. Detail of the temporary support of a neighbouring structure at the Cherefontos cite.

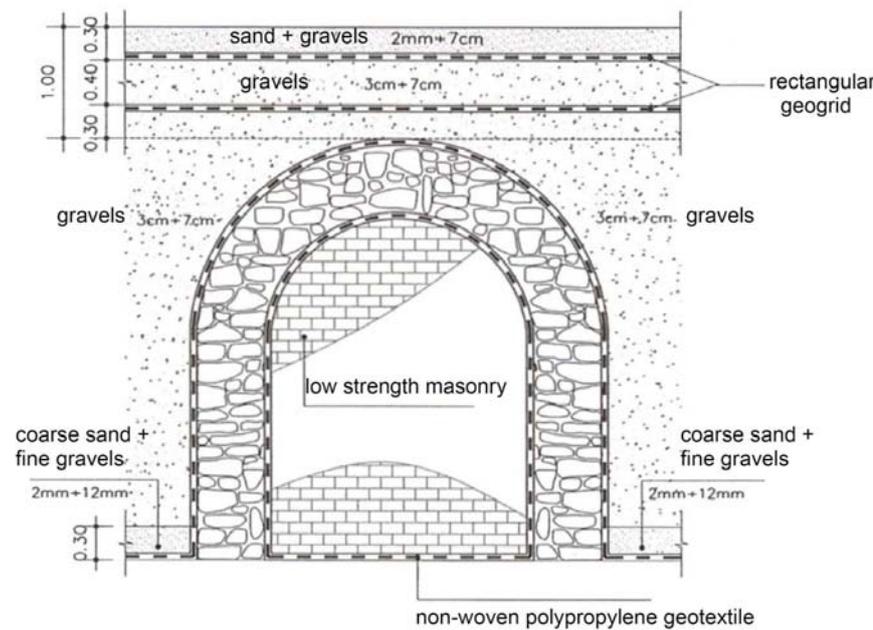
Fig. 31. Construction of the embankment over the ancient masonries.

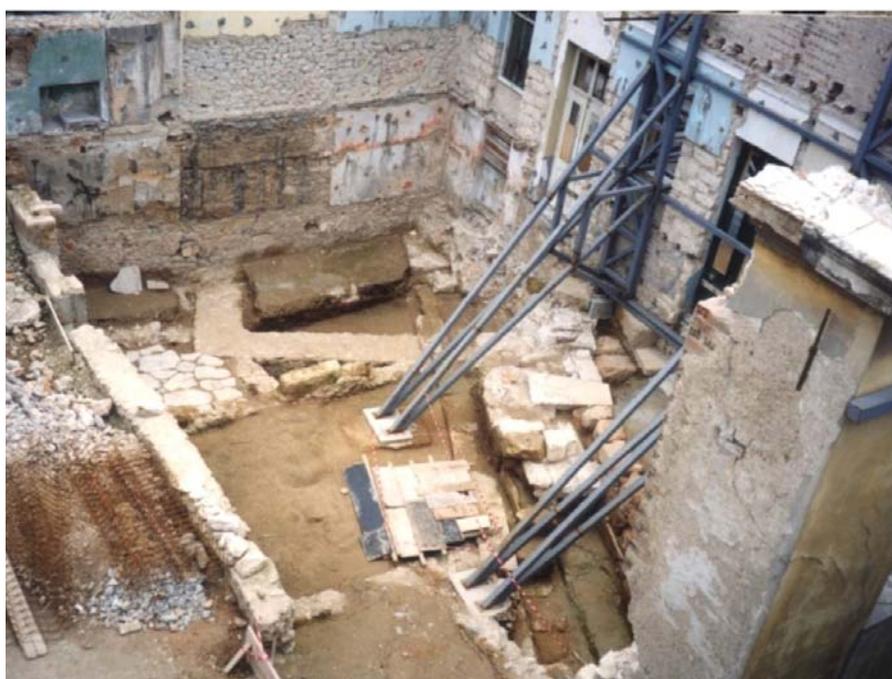
Fig. 32. Buttrussing of the facades of the twostorey building of the Islamic Art Museum.

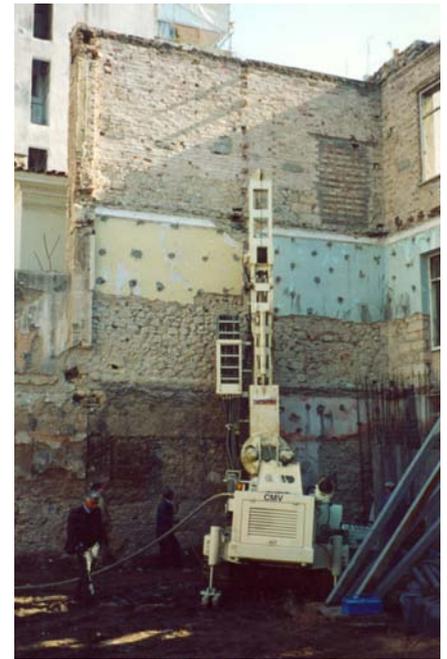
Fig. 35. Construction of micro piles at the Benaki Islamic Art Museum.

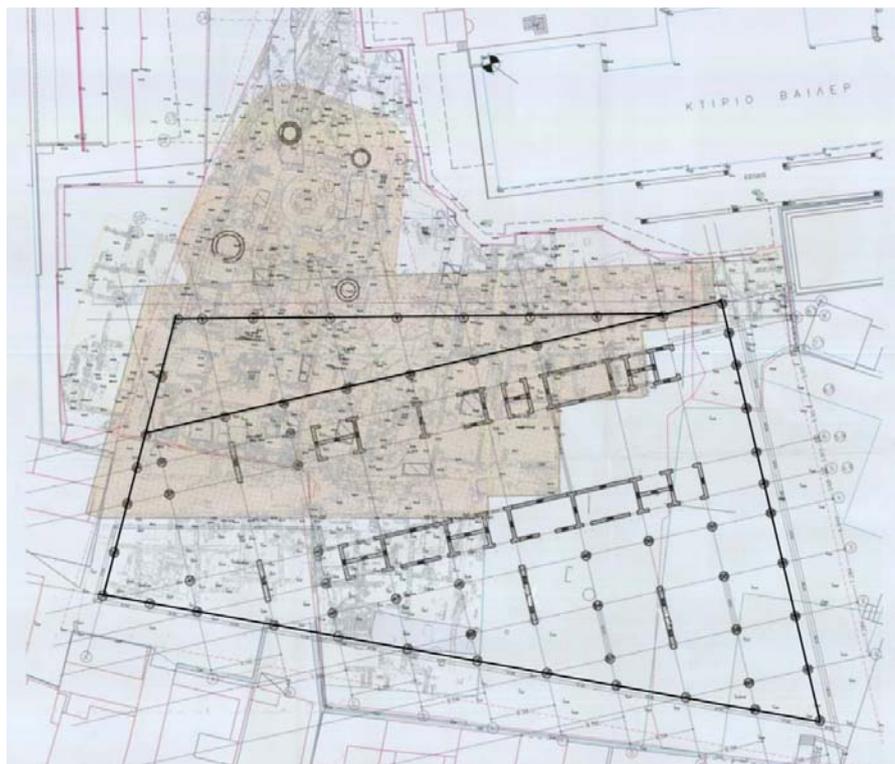
Fig. 41. Ground plan of New Acropolis Museum with the antiquities found.

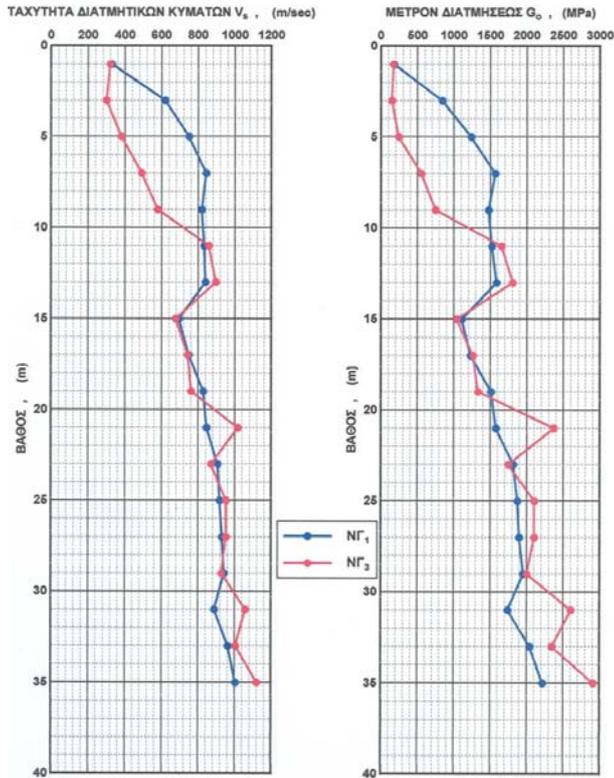
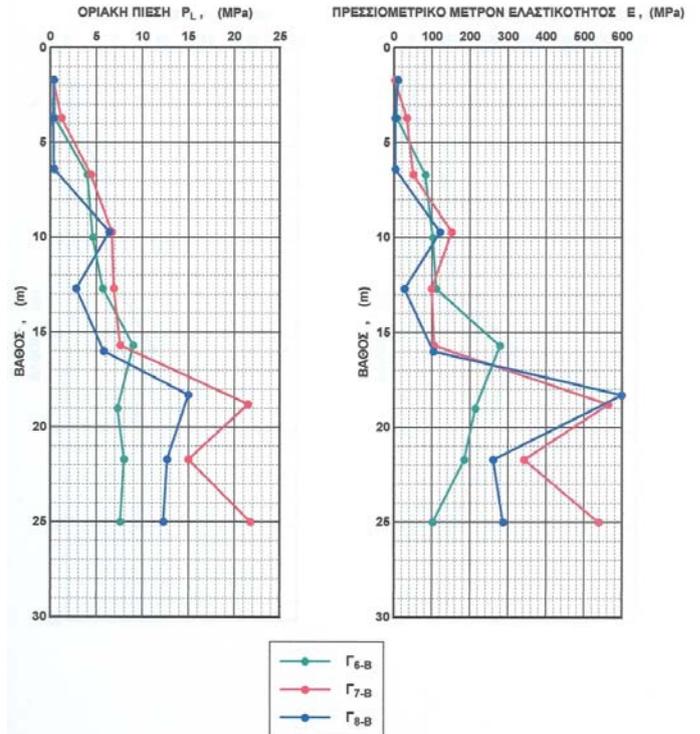
ΜΕΤΑΒΟΛΗ ΤΩΝ ΜΕΓΕΘΩΝ V<sub>s</sub> ΚΑΙ G<sub>0</sub> ΣΥΝΑΡΤΗΣΗΙ ΤΟΥ ΒΑΘΟΥΣ ΑΠΟ ΔΟΚΙΜΕΣ CROSSHOLE

ΜΕΤΑΒΟΛΗ ΤΩΝ ΜΕΓΕΘΩΝ P<sub>L</sub> ΚΑΙ Ε ΣΥΝΑΡΤΗΣΗΙ ΤΟΥ ΒΑΘΟΥΣ ΑΠΟ ΔΟΚΙΜΕΣ ΠΡΕΣΣΙΟΜΕΤΡΗΣΕΩΝ

Fig. 42. Typical results of cross-hole and pressure meter tests.

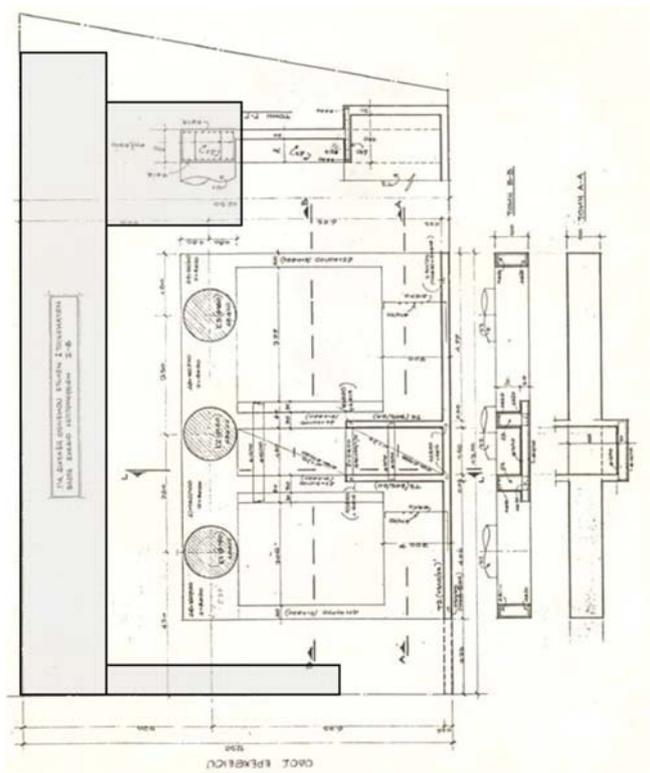
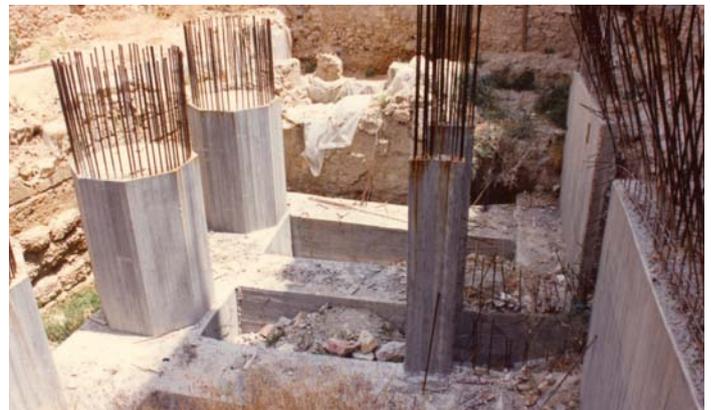
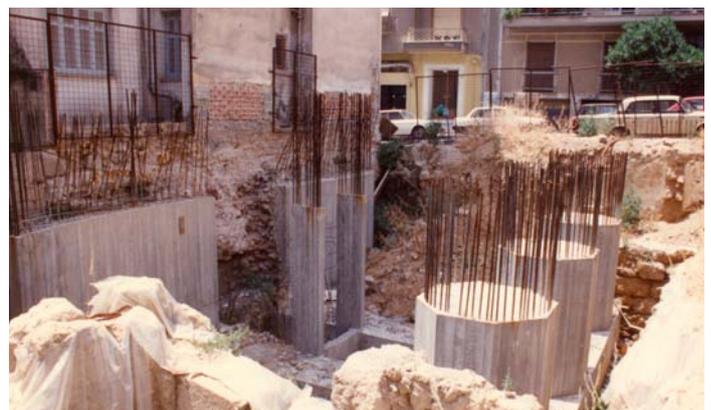
Fig. 45. Foundation of the 18 Erechtheiou Str. building; Figs. 46a, 46b. The foundation and the columns of the basement of the 18 Erechtheiou Str. building.

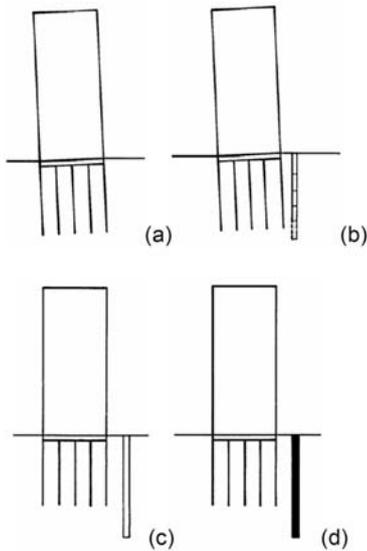
Fig. 51. Principle of the RSS method: (a) Tilting of pile – supported structure (b) Progressive drilling of boreholes on the "high" side of the foundation (c) Restoration of structure tilt (d) Grouting of boreholes.

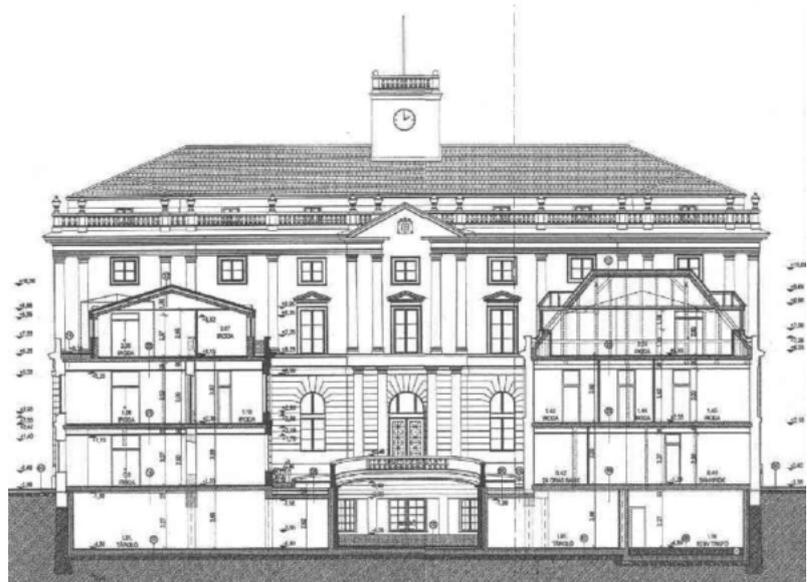
Fig. 52. Architectural section of the renewed AEB Bank in Budapest.

A very interesting example of underpinning for strengthening the foundation of a historic building was presented by Sata (2003). The AEB Bank chose a two-storied historic building for its headquarters in Budapest (see Fig. 52). The re-

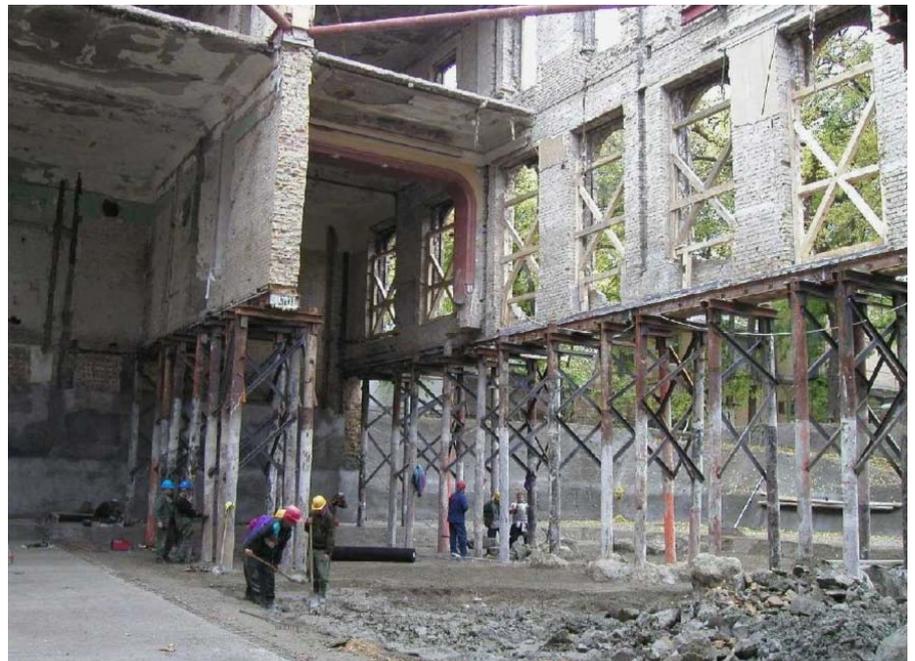
Fig. 53. The AEB Bank building "in the air".

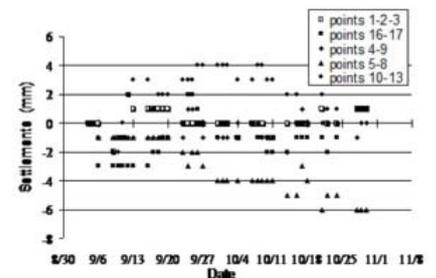
Fig. 55. Measured settlements (September-October 2002) at the AEB Bank Building.

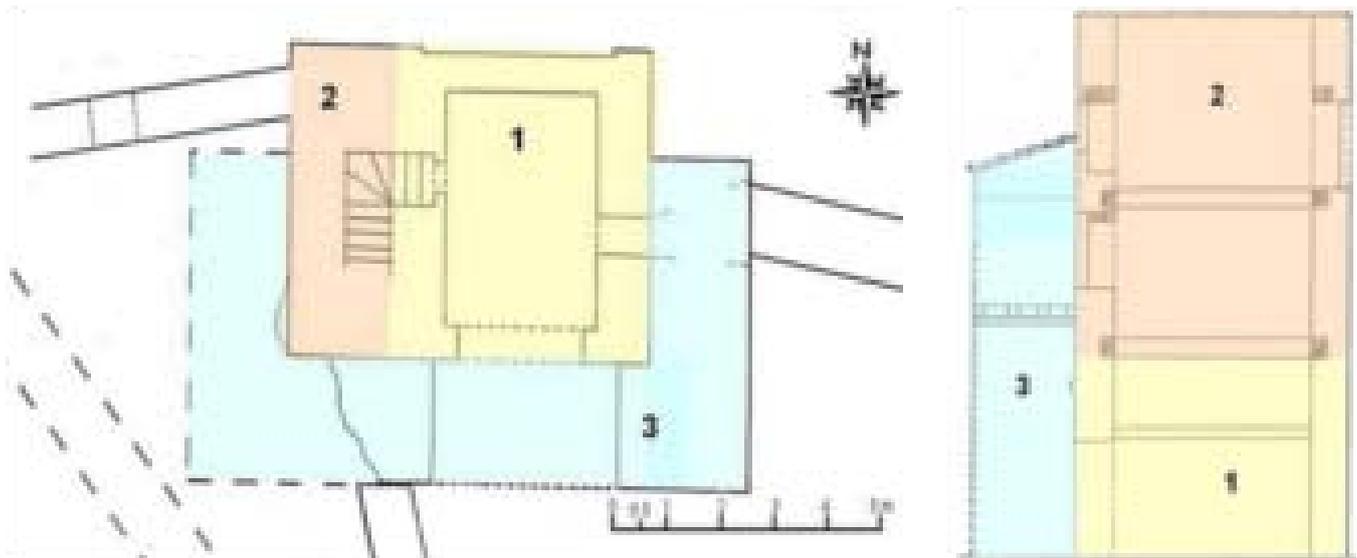
Figure 2: The 3 main construction stages of the structure, in ground plan, left, and elevation, right. 1: 13<sup>th</sup> century; 2: 14<sup>th</sup> century; 3: 15<sup>th</sup> century.

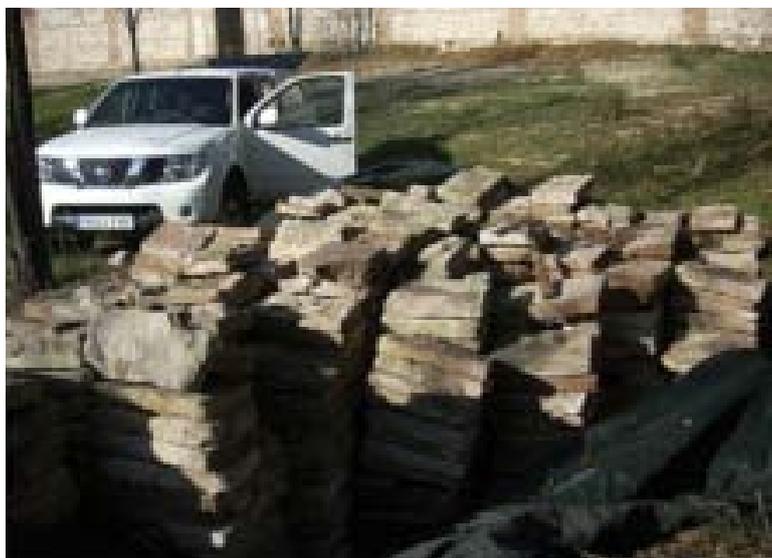
Figure 3: Stockpile of bricks from the 2005 ´s collapse of the structure, left, and bricks sampled (right).
